# Border Wall Restoration Site Reports

November 2021 - July 2022

**Myles Traphagen** - *Borderlands Program Coordinator*

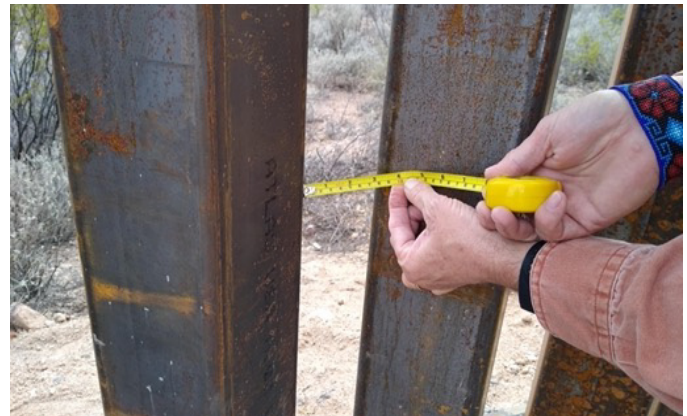
There are currently four inches between each bollard. Photo: Myles Traphagen

Bison are the largest mammals in North America, standing up to six feet high and up to almost three feet in width. Desert mule deer can have antler racks that span over 30 inches across, and rocky mountain elk, who are expanding their ranges, can have antler spreads of up to 50 inches. Therefore, a space of 44 inches would enable most species of concern to pass through. How can this be accomplished? First, we must understand how the border wall is constructed.

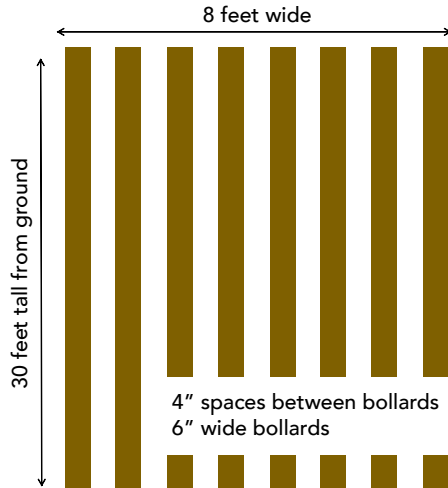
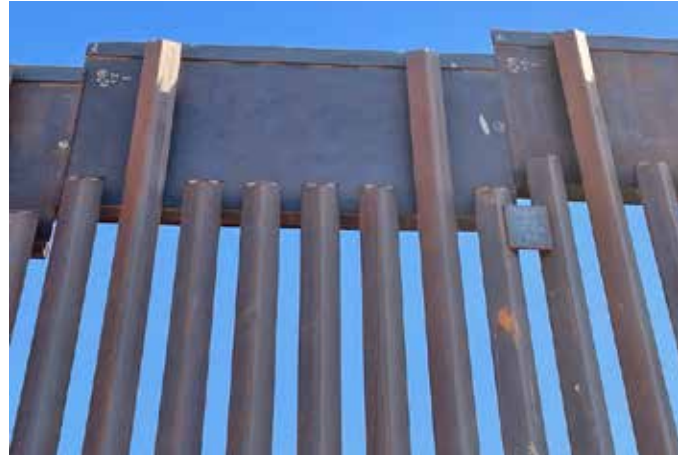
## Existing Bollard Wall Design

The steel bollards are six inch diameter ASTM 500 cold rolled square steel tubing that are 34 feet long. Eight of the bollards are welded together in what is known as a “panel” that is eight feet wide. The panels are sunk approximately four feet into the ground, leaving the top 30 feet of the bollards above ground as the fence.

Note each panel consists of 8 six-inch steel bollards with four inch spaces between each bollard.

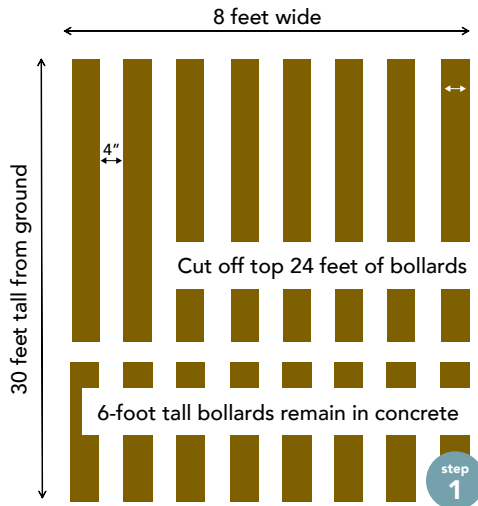
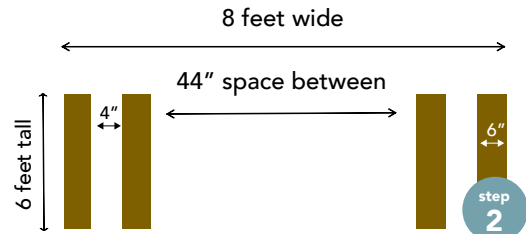
## Bollard Wall Wildlife-Friendly Design Modification

By removing the center four bollards, and leaving the two outer bollard posts on either end, a stout vehicle barrier would stand embedded firmly in concrete. Leaving the concrete footers in place is essential to maintain soil integrity and structure and reduce the chance for erosion to occur if the concrete were removed. 168 linear feet of steel could be recovered with this modification. At a cost of over \$1,000 per steel beam, and given that over 2.4 million steel bollards are currently standing, this amounts to \$2.4 billion of steel recovered by this modification.

Final wildlife-friendly design

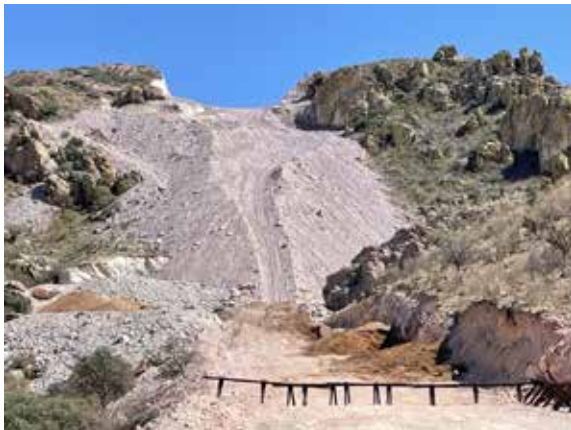
In fall of 2020 Fisher Sand & Gravel began dynamite blasting the prominent peak of Cerro del Fresnal in the Coronado National Forest in Pima County, Arizona. The peak lies about one mile east of the Buenos Aires National Wildlife Refuge. Very steep slopes of unstabilized rock and debris occur here, much of being beyond the angle of repose and extremely prone to catastrophic slope failure. Construction material and rubbish, like rebar and steel mesh are present here. There is no protective fencing to keep people, vehicles,

Looking east into Coronado National Forest at Cerro del Fresnal border wall site. May 25, 2021. 31.333623, -110.782415. Photo: Myles Traphagen

- Identify mitigation measures ————— **IMMEDIATELY**
- Install culverts ————— **IMMEDIATELY**
- Stabilize slopes ————— **IMMEDIATELY**
- Plant native vegetation ————— **FOLLOWING SOIL PREPARATION**
- Implement monitoring ————— **FOLLOWING ABOVE MITIGATION**
- Evaluate restoration success ————— **ONE YEAR AFTER MITIGATION**

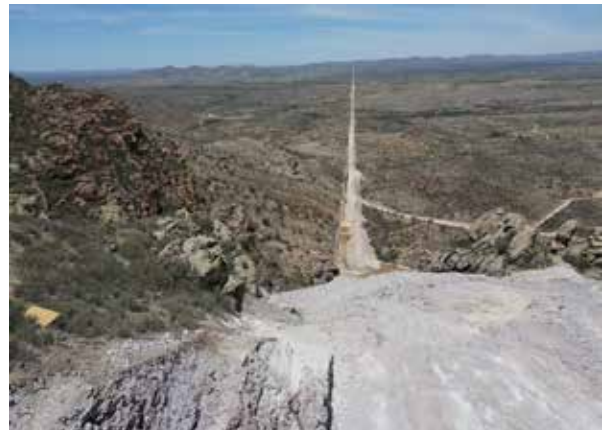
Drone view from Cerro del Fresnal looking west towards Buenos Aires NWR. May 31, 2021. 31.443148, -111.419442. Photo: Myles Traphagen

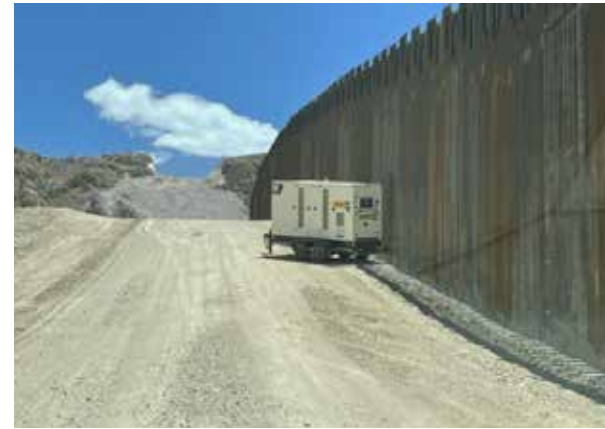
wildlife or livestock out of the area. There is no signage or warning devices to alert people to the extreme danger present here. A commercial generator from the site had slid down slope and slammed into the border wall. This piece of equipment was observed in place over one week with no effort by Fisher Industries to move the equipment. Cerro del Fresnal has essentially become an unmitigated mining site. It is recommended that MSHA take custody of the site.

Construction equipment left unsecured. Generator had slid down the slope and lodged in fence. May 21, 2021. 31.445811, -111.427886. Photo: Myles Traphagen

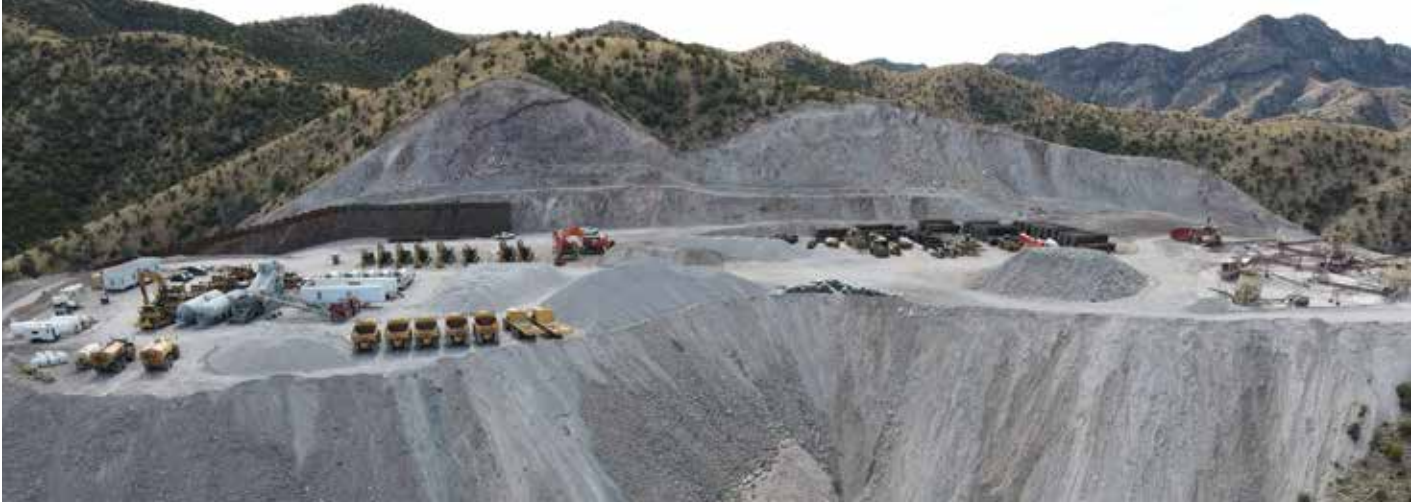
Drone photo looking south at Fisher Sand & Gravel Staging area 6 miles west of Nogales, Arizona. Coronado National Forest: Mar. 4, 2021. 31.3364, -111.077564. Photo: Myles Traphagen

In fall of 2020 Fisher Sand & Gravel began heavy earthmoving and mountaintop removal in the Pajarito Mountains of Santa Cruz County, Arizona six miles west of Nogales. This is in the Coronado National Forest and is in the Atascosa Unit 2 of Critical Habitat for the endangered jaguar. Many washes and drainages occur here, and there is a considerable amount of loose debris

that, if left bare, could wash downstream, clog drainages, and accelerate the risk of catastrophic flood damage during the next major rainfall event. There are many cattle tanks and springs that are important water sources for wildlife. The presence of disturbed bare soil will promote the colonization of invasive plant species.

- Map area of interest* ————— **IMMEDIATELY**
- Identify mitigation measures* ————— **IMMEDIATELY**
- Install culverts* ————— **IMMEDIATELY**
- Stabilize slopes* ————— **IMMEDIATELY**
- Plant native vegetation* ————— **FOLLOWING SOIL PREPARATION**
- Implement monitoring* ————— **FOLLOWING ABOVE MITIGATION**
- Evaluate restoration success* ————— **ONE YEAR AFTER MITIGATION**

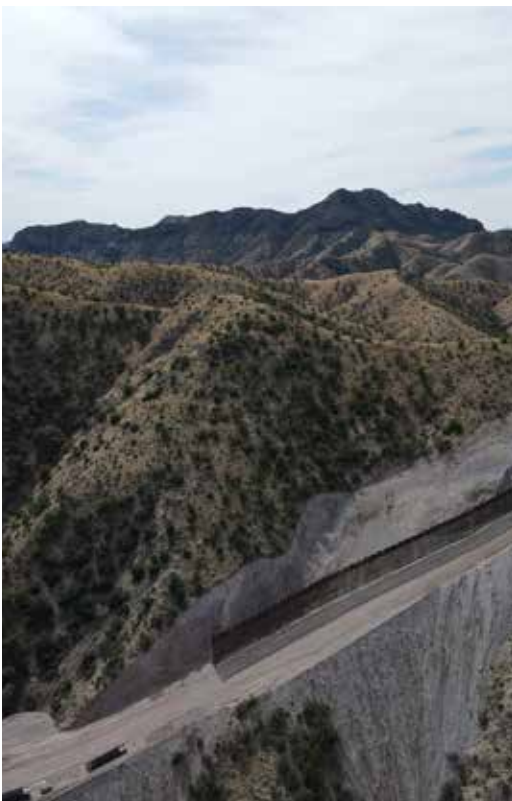
Looking west into Coronado National Forest from Fisher S&G staging area. Mar. 4, 2021. 31.336116, -111.07756. Note stretch of wall built between Jan. 20-27, 2021. Photo: Myles Traphagen

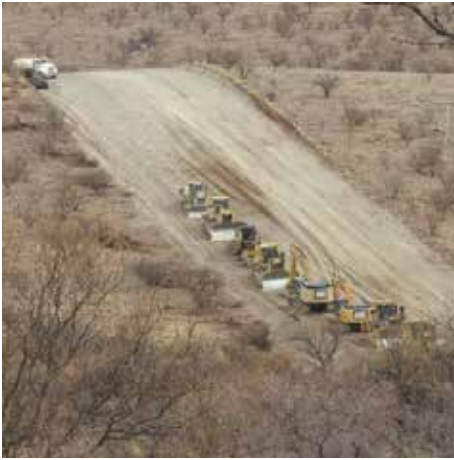
Looking east into Coronado National Forest at Roosevelt Easement border wall site. Jan. 21, 2021. 31.333623, -110.782415

- Map area of interest ————— **IMMEDIATELY**
- Identify mitigation measures ————— **IMMEDIATELY**
- Install culverts ————— **IMMEDIATELY**
- Stabilize slopes ————— **IMMEDIATELY**
- Plant native vegetation ————— **FOLLOWING SOIL PREPARATION**
- Implement monitoring ————— **FOLLOWING ABOVE MITIGATION**
- Evaluate restoration success ————— **ONE YEAR AFTER MITIGATION**

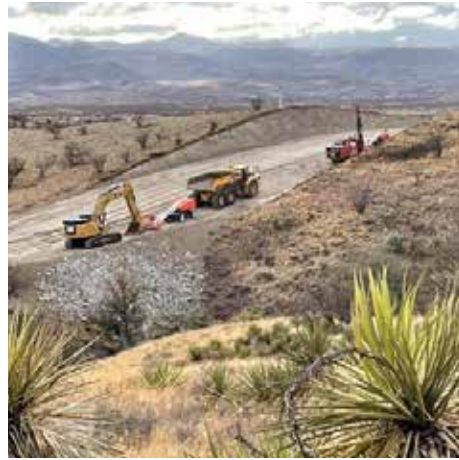
Looking west into Coronado National Forest at Roosevelt Easement border wall site. Note filled in drainage. Jan. 21, 2021. 31.333623, -110.782415

In late December of 2020 Fisher Sand & Gravel began earthmoving on the western slope of the Patagonia Mountains of Santa Cruz County, Arizona. This is in the Coronado National Forest one mile east of the Santa Cruz River, which enters the US from Mexico. This area is within critical habitat for the endangered jaguar. Numerous small washes and drainages occur here, and

there is a considerable amount of loose debris that, if left bare, could wash downstream, clog drainages, and accelerate the risk of catastrophic flood damage during the next major rainfall event. The presence of disturbed bare soil will promote the colonization of invasive plant species.

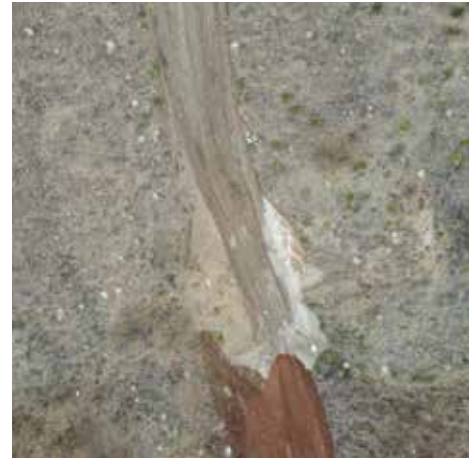
Drone view from 100m above ground level at eastern terminus of bulldozed areas. Width of bladed area is 20 meters wide. Jan. 21, 2021. 31.333583, -110.774553

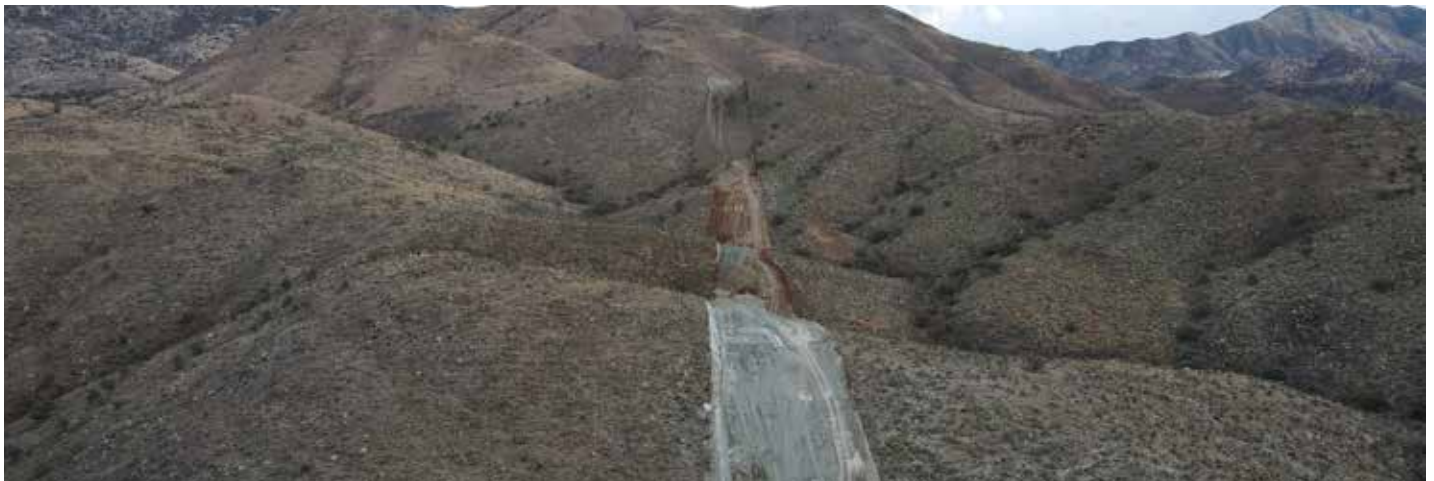
Drone view looking east into Patagonia Mountains in Coronado National Forest. Jan. 21, 2021. Photo: Myles Traphagen

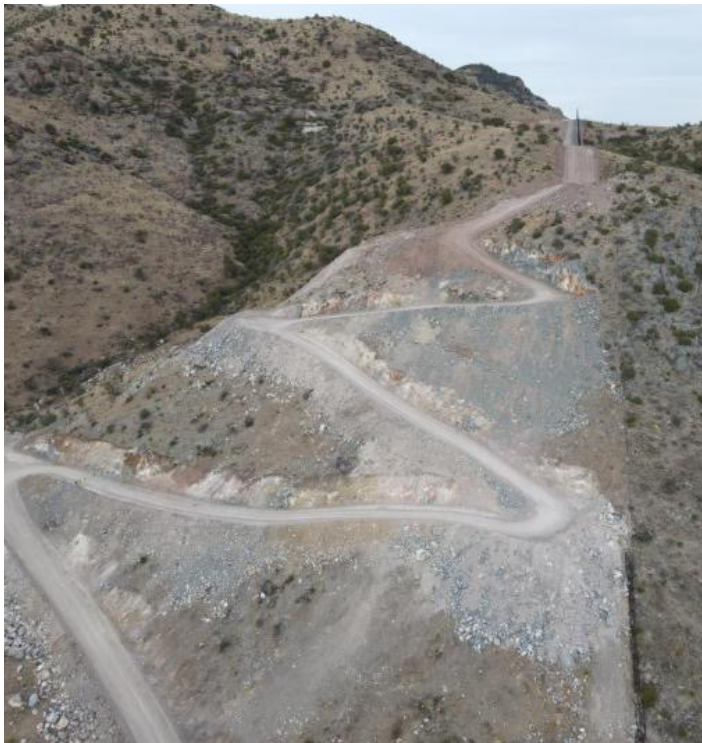
Dynamite blasting on Coronado Peak. Photo: Myles Traphagen

In late 2020 Southwest Valley Constructors (Kiewit) began dynamiting and earthmoving at Coronado National Memorial, a National Park Service property. Steep, unstabilized slopes created by dynamite blasting are present here. These constitute a public, livestock and wildlife safety hazard and accelerate the risk of catastrophic flood damage during the next major rainfall event. The presence of disturbed bare soil will promote the colonization of invasive plant species. Presently, there is a 2.65-mile zone that blasted the southern portion of Coronado Peak. This includes the first mile of the Arizona National Scenic Trail. Species affected include mountain lions, bobcats, white-tailed deer, javelina, gray foxes, badgers, and mule deer. Jaguars and ocelots have been documented in this area. It is imperative to make efforts to restore this jewel of the National Park Service system.

Map area of interest	COMPLETED
Identify mitigation measures	IMMEDIATELY
Install culverts	N/A
Stabilize slopes	IMMEDIATELY
Plant native vegetation	FOLLOWING SOIL PREPARATION
Implement monitoring	FOLLOWING ABOVE MITIGATION
Evaluate restoration success	ONE YEAR AFTER MITIGATION

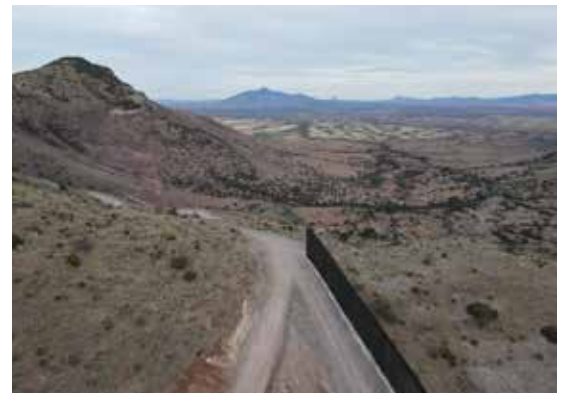
200-meter long "orphan wall" on west slope of Coronado Peak. Photo: Myles Traphagen

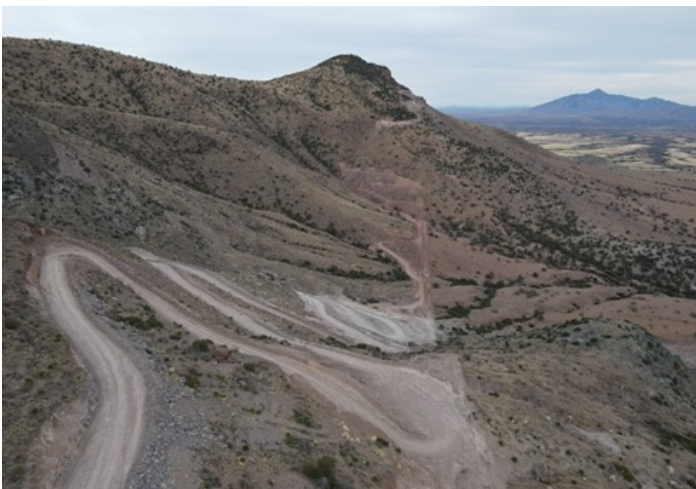
Roads created for border wall construction on southwestern edge of Coronado National Memorial. Aug. 2021. Photo: Myles Traphagen

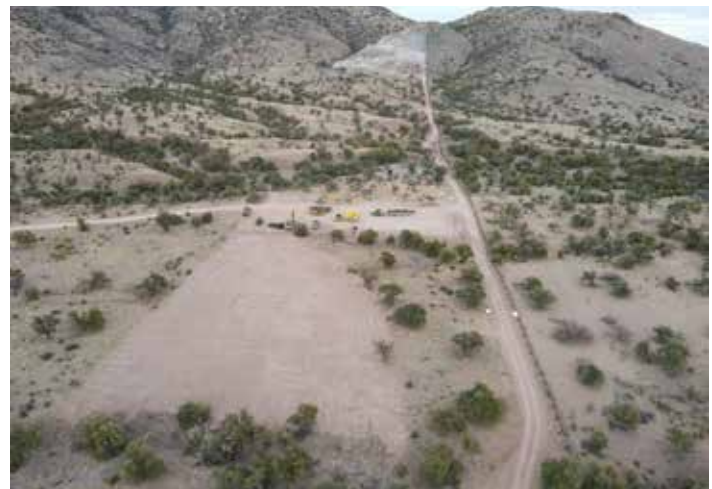
Construction staging area on western edge of Coronado National Memorial and Coronado National Forest. Aug. 2021. Photo: Myles Traphagen.

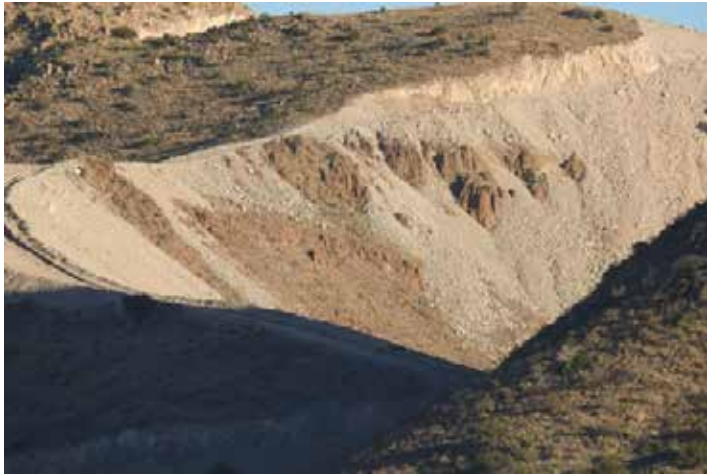
Drone view looking east into Guadalupe Canyon. Jan. 8, 2021. 31.338340, -109.093745

- Map area of interest ————— **IMMEDIATELY**
- Identify mitigation measures ————— **IMMEDIATELY**
- Install culverts ————— **IMMEDIATELY**
- Stabilize slopes ————— **IMMEDIATELY**
- Plant native vegetation ————— **FOLLOWING SOIL PREPARATION**
- Implement monitoring ————— **FOLLOWING ABOVE MITIGATION**
- Evaluate restoration success ————— **ONE YEAR AFTER MITIGATION**

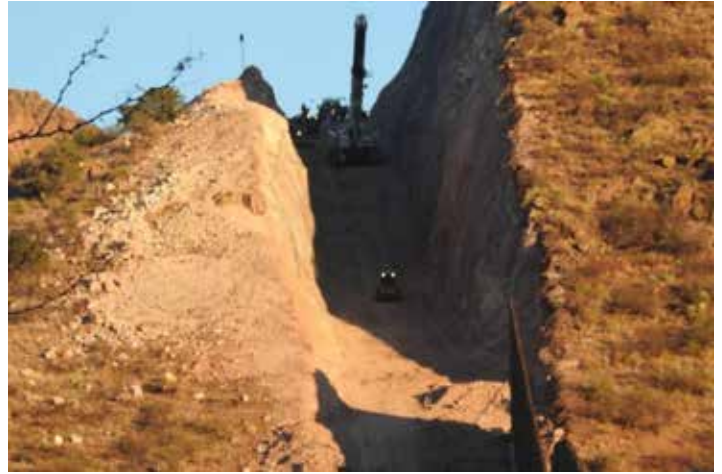
Sheer cliffs blasted into Guadalupe Canyon. Jan. 8, 2021. 31.33834, -109.0922.

There is a considerable amount of loose rock debris that, if left bare, could wash downstream, clog drainages, and accelerate the risk of catastrophic flood damage during the next major rainfall event. The presence of disturbed bare soil will promote the colonization of invasive plant species. Unstabilized sheer slopes pose extreme danger to people, livestock and wildlife.

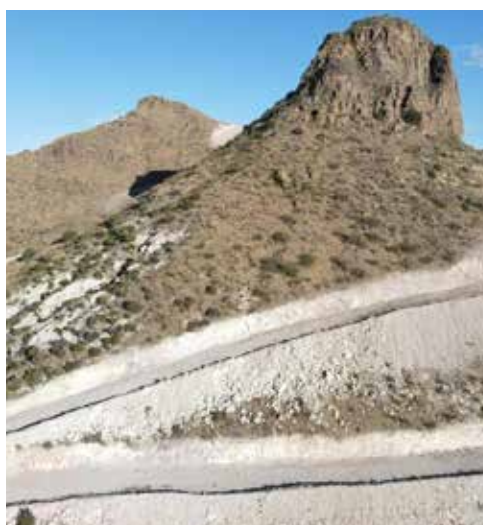
Drone photo looking east into Guadalupe Canyon. Jan. 21, 2021. 31.333623, -110.782415

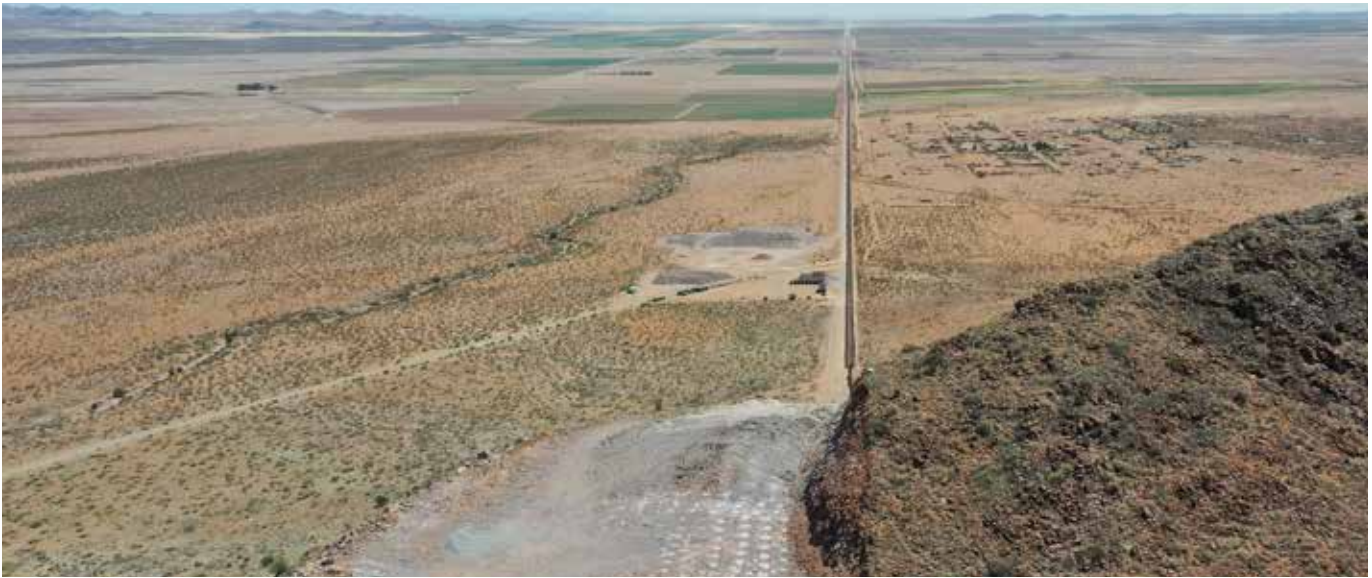
Dynamite blasting and mountaintop removal of Carrizalillo Hills, Luna County. 31.783719, -107.931514. Photo: Myles Traphagen

In late December of 2020 Southwest Valley Constructors (Kiewit) began dynamiting and earthmoving in the Carrizalillo Hills of Luna County, New Mexico on BLM property. Steep, unstabilized slopes created by dynamite blasting are present here. These constitute a public, livestock and wildlife safety hazard and accelerate the risk of catastrophic flood damage during the next major rainfall event. The presence of disturbed bare soil will promote the colonization of invasive plant species. Presently, there is

a half-mile open gap in the border fence with 30-foot tall pedestrian fencing cutting through the rugged Carrizalillo Hills on either side, blocking the movement of wildlife between the Sierra Alto mountains in Mexico and the Cedar Mountains Wilderness Study Area and extensive surrounding BLM public lands in New Mexico. Species affected include mountain lions, bobcats, coyotes, javelina, gray foxes, badgers, mule deer and endangered Mexican gray wolves.

Map area of interest	COMPLETED
Identify mitigation measures	IMMEDIATELY
Install culverts	N/A
Stabilize slopes	IMMEDIATELY
Plant native vegetation	FOLLOWING SOIL PREPARATION
Implement monitoring	FOLLOWING ABOVE MITIGATION
Evaluate restoration success	ONE YEAR AFTER MITIGATION

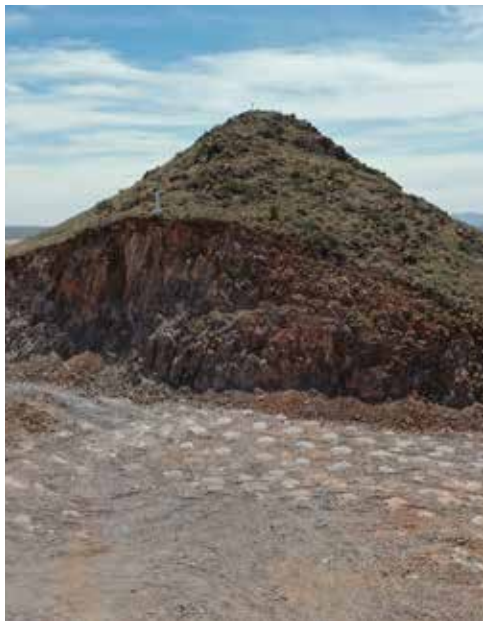
Dynamite blasting in the Carrizalillo Hills, Luna County, NM. Lat/Lon 31.784, -107.930. Photo: Myles Traphagen

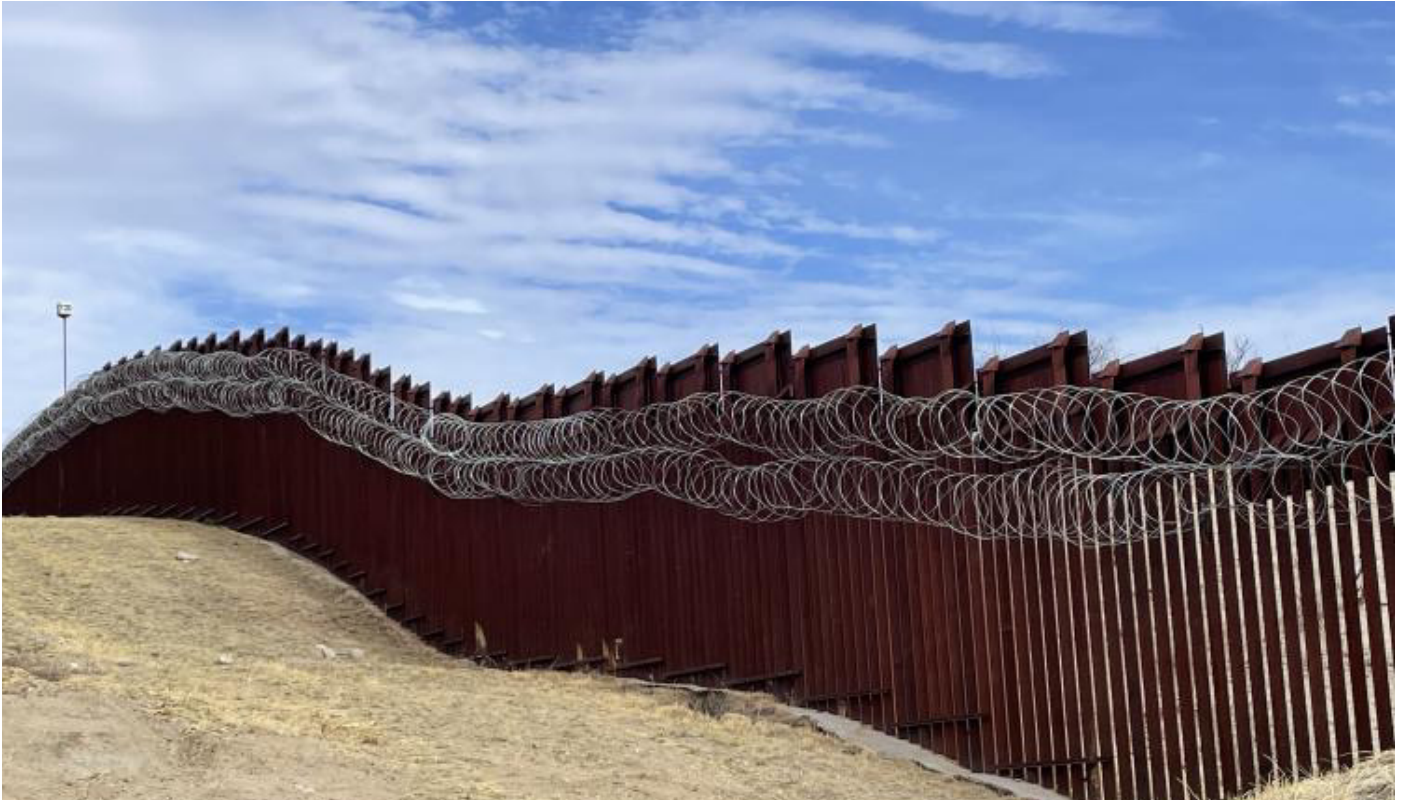
East of Santa Cruz River, Santa Cruz County, AZ. 31.333881, -110.837425.

Map area of interest ————— **IMMEDIATELY**  
Remove razor wire ————— **IMMEDIATELY**

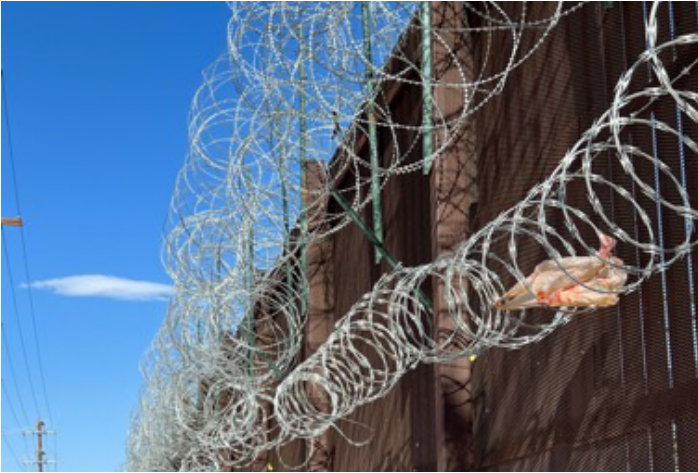
Razor wire in downtown Calexico, CA. 32.665222, -115.493217.

Between 2019 and 2020 large expanses of razor wire, (also known as concertina wire) were installed along pedestrian bollard fencing in all states sectors along the border. Urban areas are nearly all covered with this dangerous wire, creating not only a brutal eyesore that provides a stark reminder of the Berlin Wall, but also a hazard to the public and to wildlife. In border cities like Nogales, San Diego, Calexico, El Paso and Douglas, this deadly razor wire threatens the residents of these cities and places children at risk to severe lacerations. The psychological damage this infrastructure inflicts

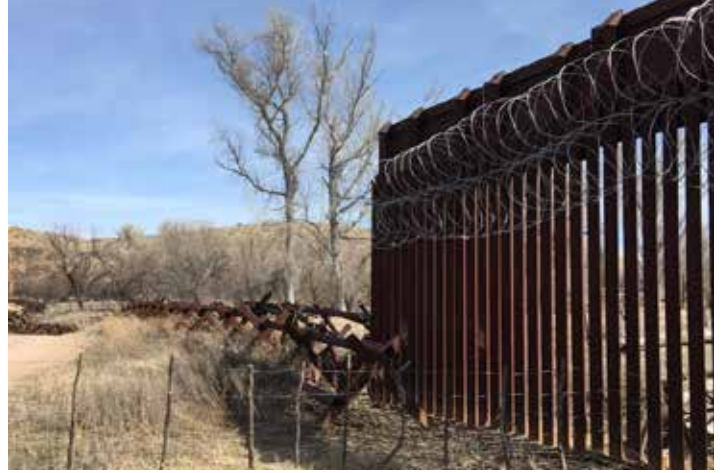
Razor wire ends at Santa Cruz River. What purpose does it serve? 31.333783, -110.851364.

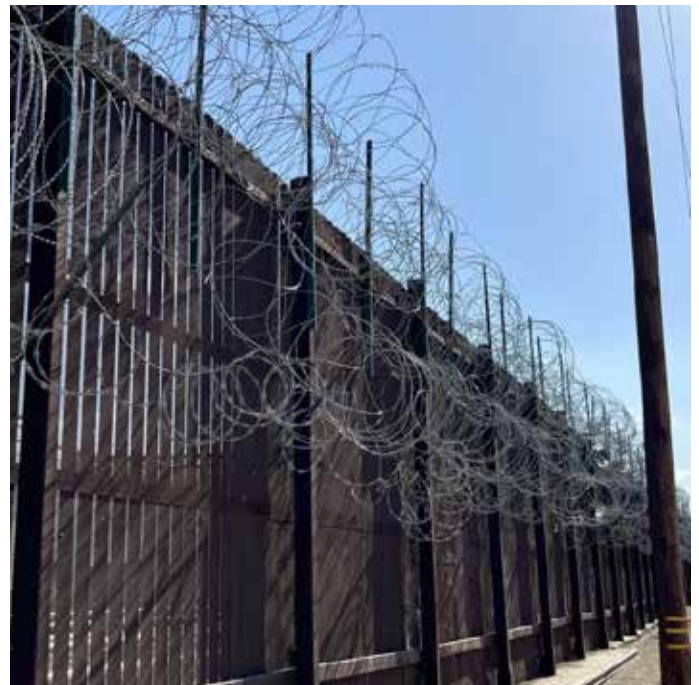
Razor wire near San Diego, CA. 32.543362, -117.019911.
